## **Stress Corrosion Cracking of Steel Component Exposed in Simulated Seawater**

### **ABSTRACT**

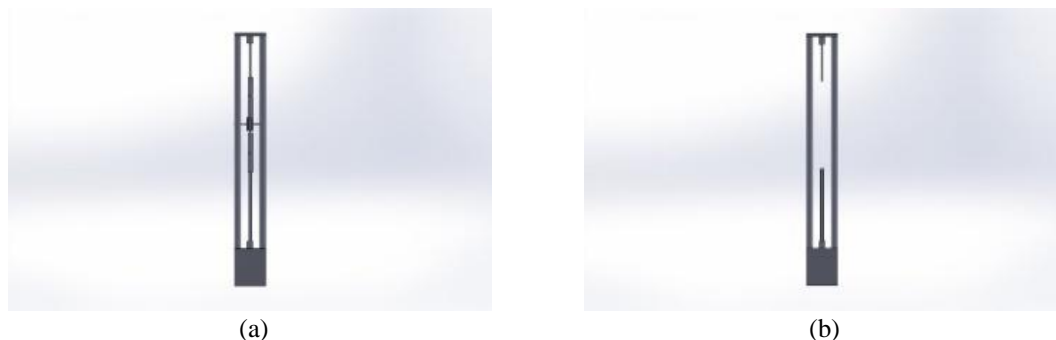
**Figure 1:** Illustration of the creep machine (a) before modification and (b) after modification.

The high temperature furnace was first removed and replaced with a small rectangular (55 × 85 mm) chamber which was fabricated from transparent acrylic material. The chamber was used as an immersion container which was filled with 3.5% NaCl solution. The grips which were fitted to the loading system of the machine to hold the specimens was designed and fabricated from stainless steel materials. A chamber holder, column fittings and chamber fittings were also fabricated and fitted to the machine to keep the specimen and the chamber in place throughout the SCC test. All the designs were made using 3D modeling software, SolidWorks. The illustrations of the initial condition and after modifications of the creep machine are shown in Figures 1 (a) and (b).

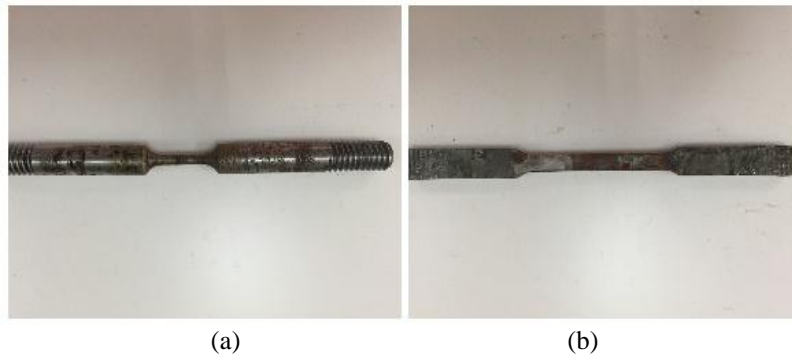
**Figure 6:** Test specimens after the SCC test for (a) round specimen and (b) plate specimen

After each SCC test was completed, the specimen was taken out from the solution chamber for visual inspection to observe any physical changes. Similarly, the specimens tested in non-corrosive environment were removed from the machine after the test has been completed. The specimens which have been tested in air (without immersion in 3.5% NaCl solution). It was observed that there are no physical changes as illustrated in Figure 5. However, the change in appearance was seen on the specimens that had undergone the SCC test as shown in Figure 6. Corroded product in the form of brownish deposit was found on the surface of the specimens and when the deposit was removed, many pits were seen on the surfaces indicating that the corrosion has indeed occurred on the surface of the specimens as depicted in Figure 6.
